TECHNICAL REPORT M-85/09
March 1985

COMPARISON OF TT-F-1098 SOLVENT-THINNED BLOCK FILLERS WITH WATER-THINNABLE BLOCK FILLERS

by
Susan Johnston

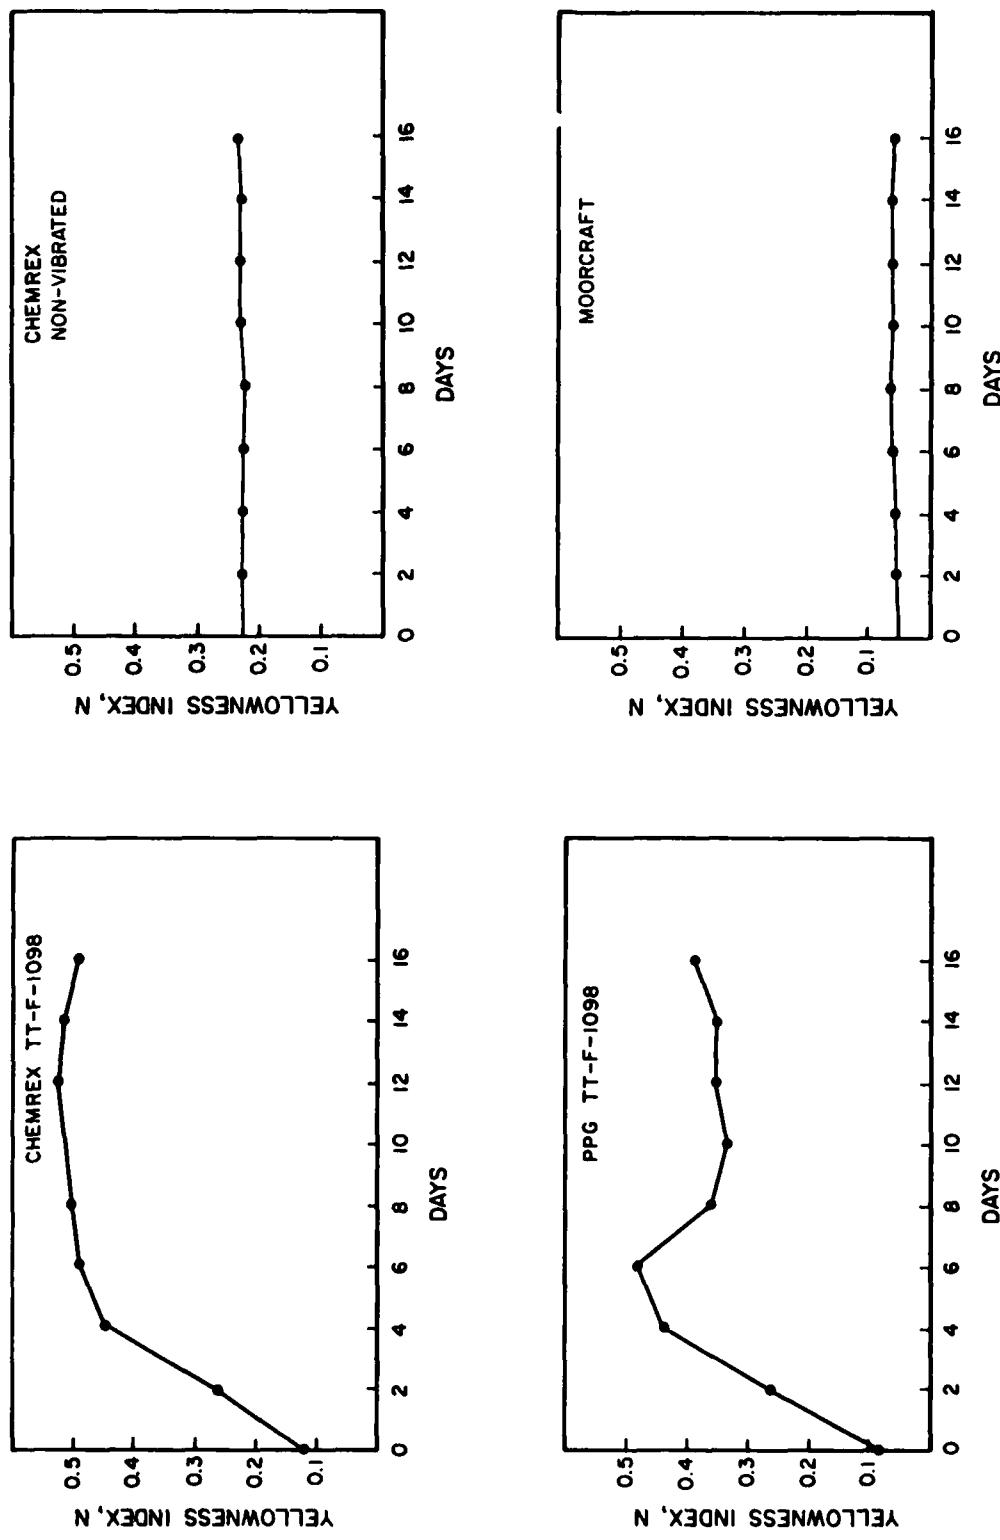
Figure 2 plots the yellowness index (N) vs. time for each of the block fillers. The latex block fillers yellowed very little during the test. The solvent-thinned block fillers yellowed very rapidly at first, then leveled off as chalk residues covered the surface. The Chemrex Nonvibrated Block Filler had an initial yellowness index much higher than any of the others, but it did not increase significantly during the test.

The latex block fillers had only traces of chalk on the surface after 16 days of exposure in the UVCON. The TT-F-1098 block fillers began to chalk heavily very early in the test.

Figure 2. Yellowing vs. time for block fillers.
